Documenta Ophthalmologica 61, 303–312 (1986). © Dr W. Junk Publishers, Dordrecht. Printed in The Netherlands.

Mechanical and biochemical effects of man-made fibres and metals in the human eye, a SEM-study

Key words: biodegradation, mechanical damage, surface roughness, prolene, perlon, supramid, titanium

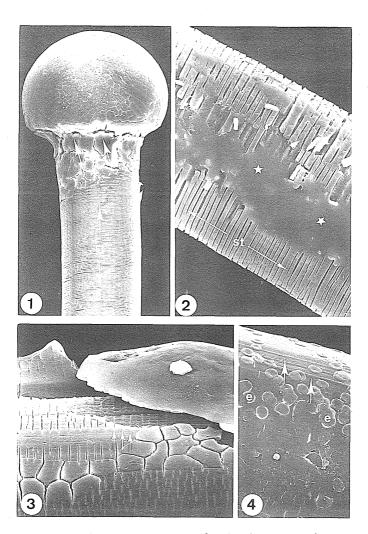
Both prolene loops showed severe degradation of the surface layer. Figure 1 shows part of one of the loops with a very regular pattern of striations (st) perpendicular to the longitudinal axis of the loop. The rounded end of the loop and the beginning of the straight part of the loop are covered with a rather thick layer of deposits of an unknown substance which contains many erythrocytes (e). The irregular cracks in this deposit (see arrows) are due to drying, a common phenomenon in SEM-specimens of inhomogenous structure. Figure 2 shows at higher magnification the very regular pattern of striations (st); some parts of the surface are covered with a thin deposit (*). comparable to the layer seen in Figure 1. The degradation of the surface layer can be observed in more detail in Figure 3. Part of the surface layer is detached, exposing the sub-surface layer, which shows a similar cracking pattern (see arrows). Although the cracking can have been enhanced by the drying process, the loops and lens were dried in air, the fact that the sub-surface layer shows a similar cracking pattern of degradation is a clear indication of biodegradation. If the phenomenon we observe were the result of the drying of a deposit, then the cracks in it would have a much more irregular character, like the cracks seen in Figure 1 on the rounded top. Moreover the total diameter of the degraded loop has certainly not increased, which would be the case if the result we observe was caused by the deposition of material.

That part of the loop (close to the lens) which was not in contact with tissue did not show the degradation phenomenon, but was merely covered with a very thin deposit, consisting mainly of erythrocytes (e), Figure 4. The layer of deposit is very thin, as can be concluded from the longitudinal lines, caused by the manufacturing process, which are still visible despite the deposit (see arrows).

Figures 1-4. Prolene: Figure 1 (155 \times), part of prolene loop; e = erythrocyte covering; st = striations of biodegradation; arrows denote deposited organic matter. Figure 2 (370 \times), degraded surface; * = deposited organic matter; st = regular pattern of striations. Figure 3 (770 \times), detail of degraded surface layer. Figure 4 (370 \times), non-degraded prolene surface; e = erythrocytes; arrows denote manufacturing grooves.

We think that the surface changes observed in the implanted prolene are the result of biodegradation by the enzymatic action of the tissue fluids. Although the cracking pattern on the surface may be enhanced by the drying, the changes are the primary result of chemical changes on the surface.

This conclusion is supported by the images of the *sub*-surface layer, where lines appear perpendicular to the longitudinal axis of the loop, which are not present in the control sample. In some places a deposit is visible on top of the surface layer of the implanted prolene; this layer is very thin and not in any way comparable with the attacked layer. If the phenomenon of what we call biodegradation is the result of a deposit of, for example, a proteinic material, a quantitative increase in the average diameter would be the result. The total diameter at such sites did not increase but, on the contrary, tended to decrease slightly. Moreover the cracks (striations) are so regularly spaced over a large part of the implanted loops that they must be the result of prolene degradation and not of the mere drying of a deposit.

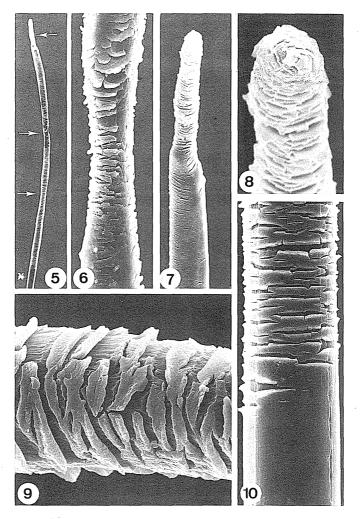
not show this. The attack was so serious that the ends became so thin that they lost their strength and broke off. Figure 5 shows the broken end of one of the sutures at low magnification. In several places (see arrows) the suture had a smaller diameter than average. This considerable decrease in diameter is something we did not observe with prolene. The main part of the suture in Figure 5 shows a degraded surface, except for the part indicated by (*).

A thinner part of the suture is shown in more detail in Figure 6, the

Figures 5-10. Perlon: Figure 5 (38 \times), low magn. broken Strampelli suture; arrows denote decreased diameter; * = non-degraded part. Figure 6 (390 \times), detail of suture with decreased diameter. Figure 7 (175 \times), broken end of suture. Figure 8 (595 \times), detail of Figure 7. Figure 9 (1330 \times), detail of degraded surface. Figure 10 (450 \times), transition non-degraded (lower part) – degraded surface.

surface of the suture is degraded. The broken end of the suture is depicted in Figure 7, it has a considerably decreased diameter and the surface is degraded. The broken end is shown in Figure 8 at high magnification, note the rough outer surface.

Although not exactly the same, the general pattern of degradation of the surface layers of perlon (Figure 9) and prolene (Figure 2) is comparable. A similar pattern is found on the sub-surface layer of perlon to that seen in

prolene. That part of the suture which had not been in contact with tissue did not show these effects of biodegradation. Figure 10 shows such a transition area in more detail, the lower part of the picture represents the non-degraded surface of the perlon structure.

The effects seen in the perlon material are also the result of biodegradation; in certain places the material got so thin that it lost its strength and broke. Supramid material showed minor degradation effects, longitudinal cracks which may be related to the manufacturing grooves to some extent. In one case (see Addendum) we found, in a very small portion of the total length of all the loops, a similar degradation effect to that seen in prolene and perlon. Thus supramid can undergo biodegradation as well.

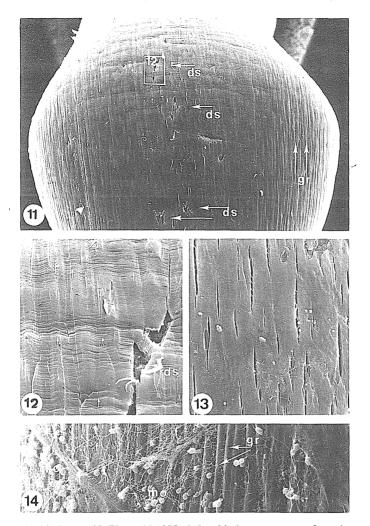
Figures 11–14. Supramid: Figure 11 (455 \times), bend in loop; gr = manufacturing grooves; pl = lines perpendicular to grooves; ds = surface damage. Figure 12 (1530 \times), detail of Figure 11. Figure 13 (950 \times), longitudinal cracks in surface. Figure 14 (1530 \times), gr = manufacturing groove; f = fibres; mo = microorganisms.

The supramid material showed, in particular at bends in the loop, a fine network of lines (see arrows) perpendicular to the longitudinal manufacturing grooves (gr) of the loop (Figure 11). On the median part of the loop, clear evidence of surface layer damage can be seen (ds). Figure 12 shows a detail of such a site and its relationship to the fine network already mentioned. In Figure 13 longitudinal cracks are visible on the surface of the supramid loop, possibly the start of biodegradation. These cracks are found in the vicinity of bends in the loop at some distance from them, implying that this type of degradation is related to weak spots in the loop, particularly bends due to the manufacturing process. The general pattern of the surface is not one of severe degradation, as compared to the degradation seen in prolene and perlon, at least not in the loops we investigated.

The relatively rough outer surface of supramid, as compared with prolene and perlon, certainly facilitates the adherence of fibres, cells and microorganisms, as can be seen in Figure 14. The picture shows the almost complete diameter of the loop with fibres (f), possibly fibrin, and microorganisms (mo) covering the manufacturing grooves (gr) of the supramid.

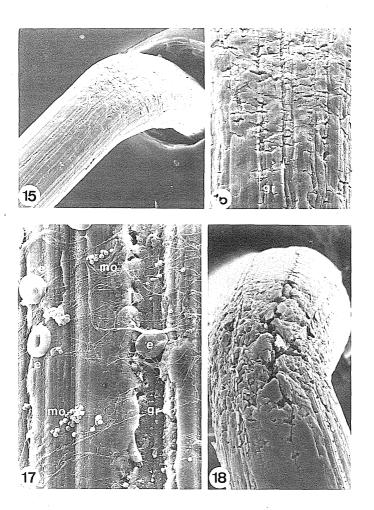
Titanium showed a rough outer surface, particularly at bends in the loop; in the straight part of the loop the longitudinal lines can be seen caused by the manufacturing process (Figure 15). The longitudinal grooves (gr) and the cracks more or less penpendicular to them can be seen in more detail in Figure 16 (area (A) of Figure 15). The roughness of the titanium surface facilitates the adherence of microorganisms (mo), fibre-like material and cells, especially erythrocytes (e), visible against the background of manufacturing grooves (gr) in Figure 17.

This roughness is already present in non-implanted material, as can be observed in Figure 18. The cracks in the surface layer particularly at the bends in the loop, visible in non-implanted as well as implanted material (see Figure 16), are some kind of mechanical degradation probably caused by, or at least initiated by, the manufacturing process.

This roughness also contributes considerably to irritation and inflammation of the tissue which is in contact with this material. In comparison with titanium, stainless steel-vanadium and, in particular, platinum wire have a much smoother surface.

Figures 15–18. Titanium: Figure 15 (190 \times), bend in implanted loop. Figure 16 (455 \times), detail of surface of bend; gr = grooves. Figure 17 (1230 \times), detail of loop surface; mo = microorganisms; e = erythrocytes; gr = manufacturing groove. Figure 18 (345 \times), detail of bend in non-implanted loop.

Both supramid and titanium have initially a rather rough outer surface, which facilitates adherence and, in the case of titanium, contributes to irritation and inflammation of the tissue with which it is in contact.

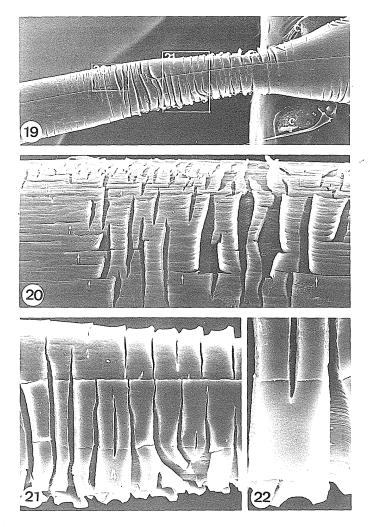
one loop situated close to the IOL (see Figure 19), which showed severe biodegradation. The diameter of the loop had decreased at this site. The IOL showed some cell deposits around the loop 'entrance' (c). The degradation pattern is quite similar to that found in prolene and perlon (see Figures 20 and 21, both details of Figure 19). From Figure 20 it seems logical to assume that the degradation is connected with the surface morphology of the supramid surface. The longitudinal cracks (see arrows) are comparable with those found in Figure 13, which can be related to the manufacturing grooves. The

Figures 19–22; Supramid: Figure 19 (75 \times), part of loop close to IOL; c = cell deposit. Figure 20 (455 \times), detail of Figure 19; arrows denote longitudinal cracks. Figure 21 (275 \times). detail of Figure 19; severe degradation of surface. Figure 22 (610 \times), detail of Figure 21, inside of crack.

striations perpendicular to these cracks are comparable with the striations found in prolene (Figure 2) and perlon (Figure 9), although less regular.

Figure 22 shows more detail of the inner part of the surface layer (enlargement of part of Figure 21). From this picture we can conclude that the loosened surface layer does *not* have an amorphous structure, which would be the case if it was merely a deposit of, for instance, proteinic material. Arrows denote the cross-section of the loosened surface layer.
